Roof Material Takeoff Report – 002067

Contact George Parker-Grand Island School

Address Colusa County, CA

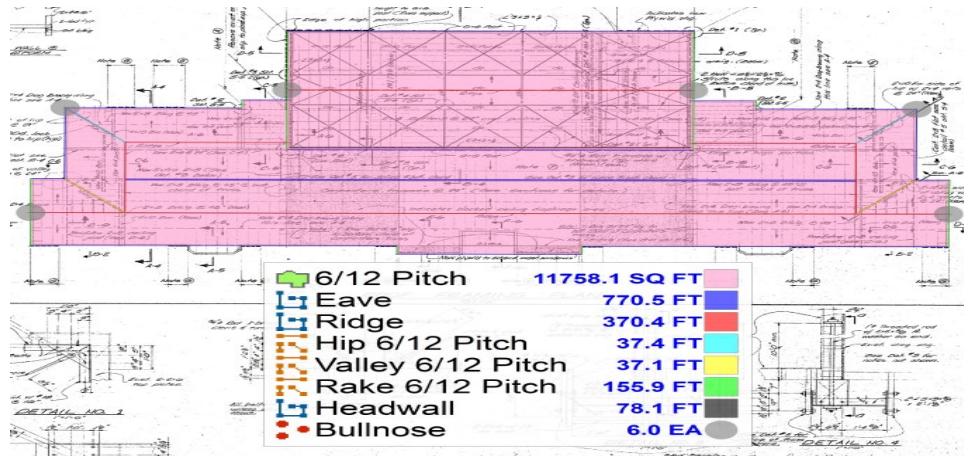
Summary Data	#SQ	117.6
	Eave(ft)	770.5
	Hip(ft)	37.4
	Ridge(ft)	370.4
	Valley(ft)	37.1
	Rake(ft)	155.9
	Bullnose	6
	Headwall(ft)	78.1

Remarks: There are no measurements provided to verify that the scale is correct. Please verify totals prior to placing an order. Full size legend is uploaded in SF.
